jhl_sttm_u_032

DRAINED FLASHING JOINT AT EXTERNAL CORNER

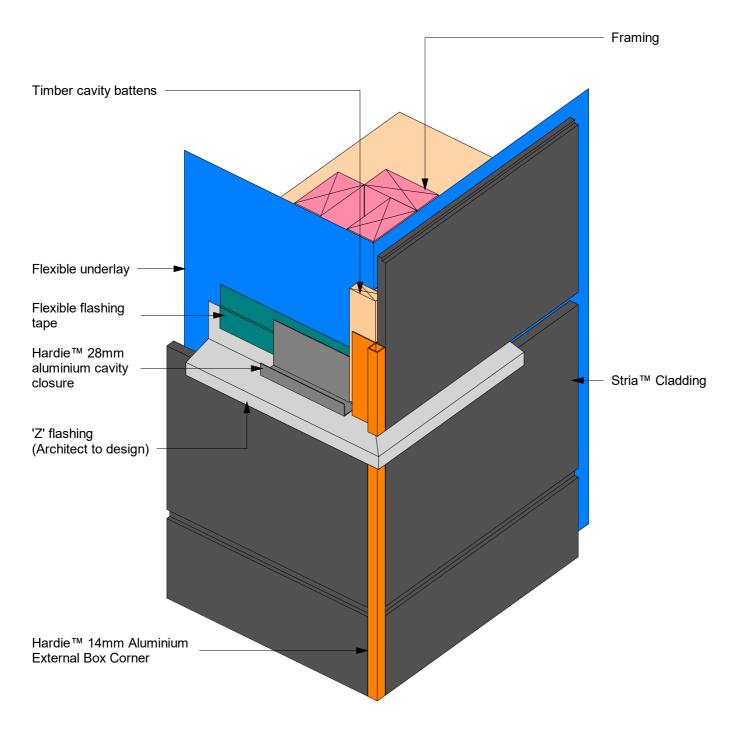
Note: Site cut edges to be primed
